## **MEMORANDUM**

Subject: Technical Memorandum on Regional Water Board's Administrative Civil Liability Complaint Issued to Del Mar Farms

Date: July 3, 2012

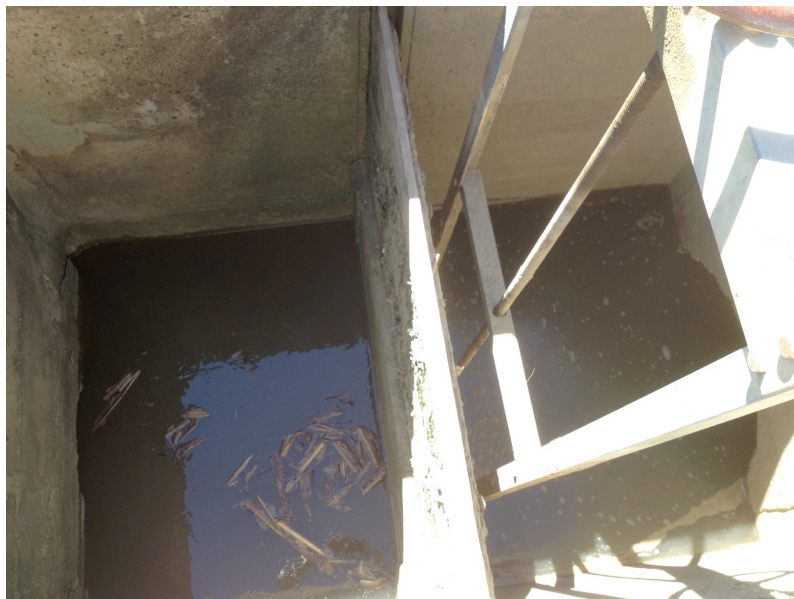
**Figure 1**  
**Amaral Line Control Box**

There are many control boxes along the Amaral Line that are used to control and divert water to fields for irrigation. The control boxes have a rectangular footprint and protrude into the ground to varying depths. In the center of the boxes are a weir and canal gate used to control the water level upstream. The irrigation turnouts are on the upstream side of the box and the drainage inlets are on the downstream side. **Figure 1** shows the inside of a control box (photo taken during my field review).

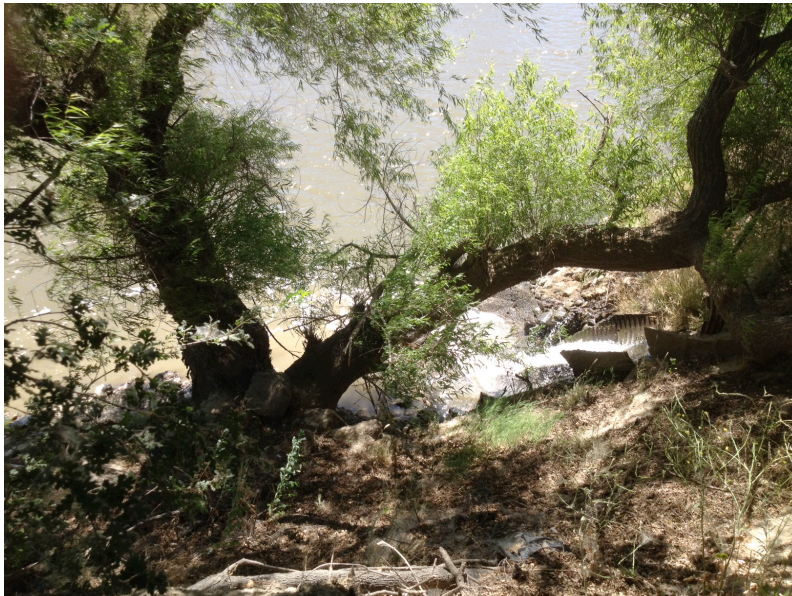
**Figure 2**  
**Amaral Line Outfall to SJR**

The outfall of the Amaral Line in the River consists of a pipeline protruding from the embankment with minimal erosion control (i.e., rip rap) (see **Figure 2**, also taken during my field review).

The River samples taken downstream from the outfall certainly were taken at a location where not much blending with upstream water had occurred, and thus may not represent a fair location to check for River turbidity objective. Regional board photos, my field observations, and River flow data demonstrate the lack of blending occurring only 100 feet downstream of the Amaral drain outfall. The outfall is located on the far bank of the slowly-flowing and very wide river as it makes a U-turn. The outfall's location

on the turn, along with the river's wideness, brush and other surface obstructions, and associated slow velocity result in outfall water "hugging the bank" without much blending. The San Joaquin River flows for the three days in question ranged between 2,000 to 6,000 cfs (measured by the U.S.G.S. at Crow Landing on those days). These San Joaquin River flows are 400 to 1,200 times higher than outfall flows estimated by Terry Bechtel on May 19<sup>th</sup>, which are the only outfall flows estimated for the three days in question. Even if one was to assume that the end of field turbidity measurements represented the turbidity discharged to the San Joaquin River from the Amaral Line on those three days, and that the May 19<sup>th</sup> outfall flow estimate was representative of all three events, actual increases in River turbidity would be on the order of 1% or less after complete mixing occurs, which is well below the 20% increase that is part of the objective cited in the ACL.

It was also apparent in the photos and by review of the River during my field review that sediment from the bottom of the River was being stirred up and re-suspended from the bottom of the River by the turbulence from the Amaral drain outfall. This undoubtedly increased turbidity 100 feet downstream.
